## **Water and Sanitation: A *preliminary* assessment of water supply on selected Odendaal Farms in southern Namibia**

**\*Faith A. Simataa**

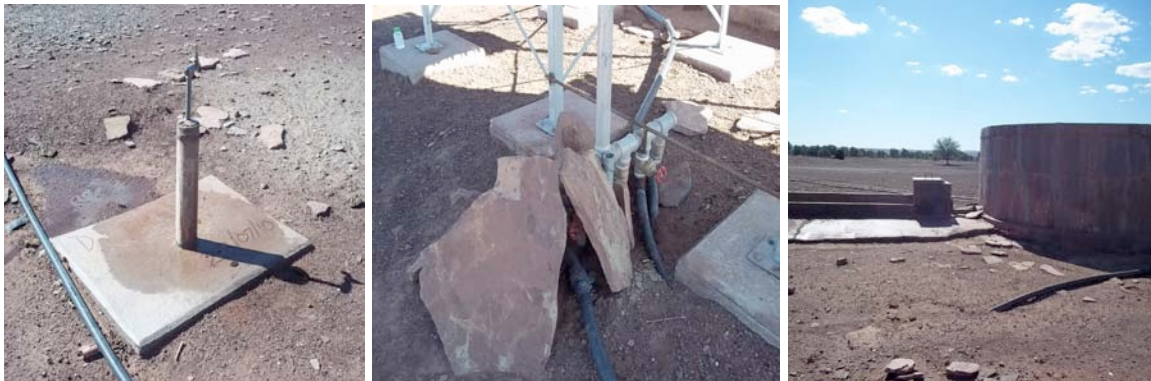
Exposed cables and water pipes are a concern and it is recommended that they be covered deep in the ground to prevent harsh effects from the sun and trampling by animals to extend their lifespan. The infrastructure overall seems to be in a good condition and well taken care of by the community, requiring minimal maintenance.

Figure 1. The water infrastructure at Khaitsub farm. The middle picture shows some of the measures taken by the community members to protect the infrastructure. In all the pictures it clearly shows the extent of exposed water pipes.

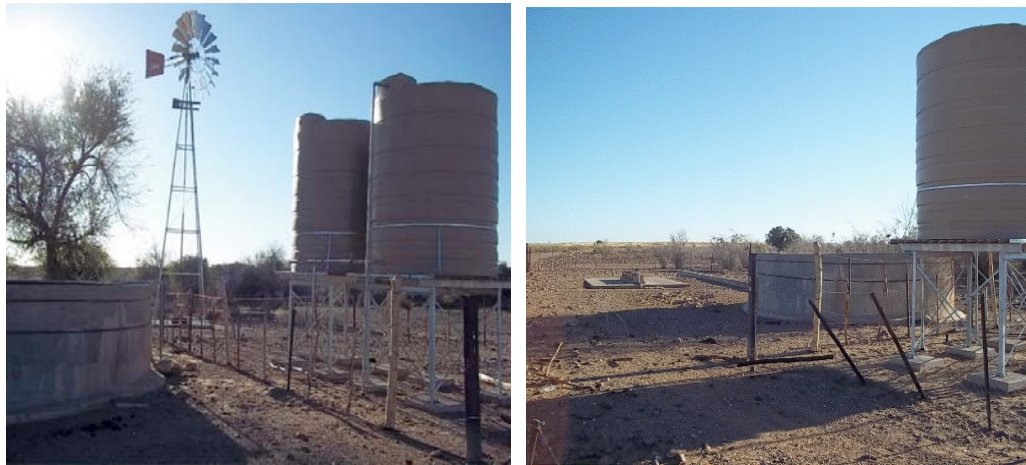
Figure 2 The layout of the infrastructure around the water point: a non functional windmill, water tanks, a farm dam and a livestock watering trough in the background (second picture). The fence around the water point has collapsed and is not maintained.

Currently the windmill is not functional, the tank taps are broken and need repairing, the standpipe handles been removed and possibly misplaced, needing replacement; and the people have no insight or skills to repair and maintain the infrastructure. Other problems noted were the inadequate installations and exposed pipes at the water point. The latter can be addressed by digging deep enough trenches to embed the pipes, thereby avoiding damage by livestock foraging and drinking water in the area. Fencing off certain areas would also offer solution to the damage of water infrastructure by the animals.

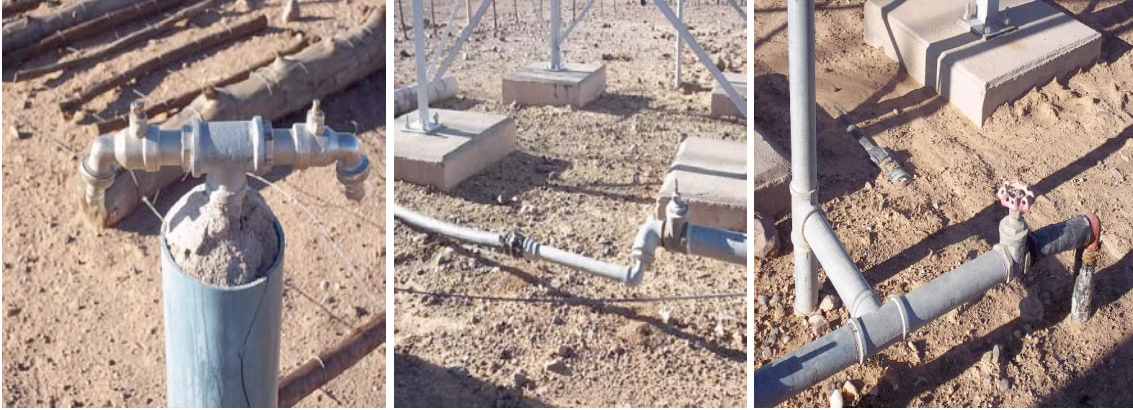
Figure 3 Maintenance is an issue in managing the water point, as depicted in the pictures, where a neglected standpipe with misplaced handles and exposed water pipes are visible

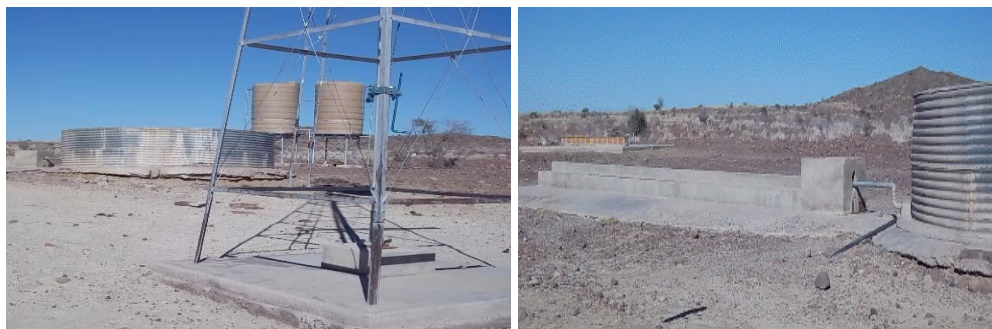
Figure 3 Infrastructural layouts at the water point

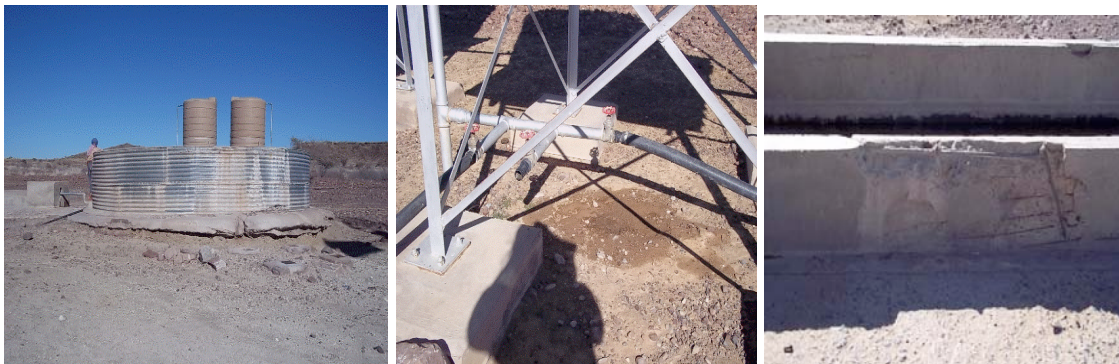
Two troughs were observed, one next to the dam and the second one a few meters away from the dam. However, the kraal was located well away from the water point. Similar to Doringdraai Farm, the dams and tanks were also repaired by the DRWS in 2008. The pump however was never maintained for as long as the caretaker can remember. From the observations the concrete trough next to the dam requires cementing to strengthen the infrastructure. Upon inspection it was also clear that the fittings used were of a poor quality due to the leakages observed. Pipes are required to address this problem.

The caretaker, in an attempt to repair some minor damages, did some fittings, but are not sustainable. He placed the blame of all the maintenance issues on the DRWS for making use of ‘cheap’ fittings which are not sustainable. Soil erosion around the farm dams is another evident feature as shown in picture (figure 4, left). There is a need to strengthen the support the foundation of the reservoir where erosion has occurred. Exposed pipes are yet another concern on the farm. The sole standpipe is in an acceptable condition judging from the infrastructure. The community members attributed their removing of the tap handles to avoiding water wastages brought on by animals tempering with the tap. Livestock movement around the water infrastructure should thus be regulated to preserve the equipment.

Figure 4 Natural and Infrastructural challenges (from left to right): soil erosion around dam, leakages, fragile infrastructure of water troughs

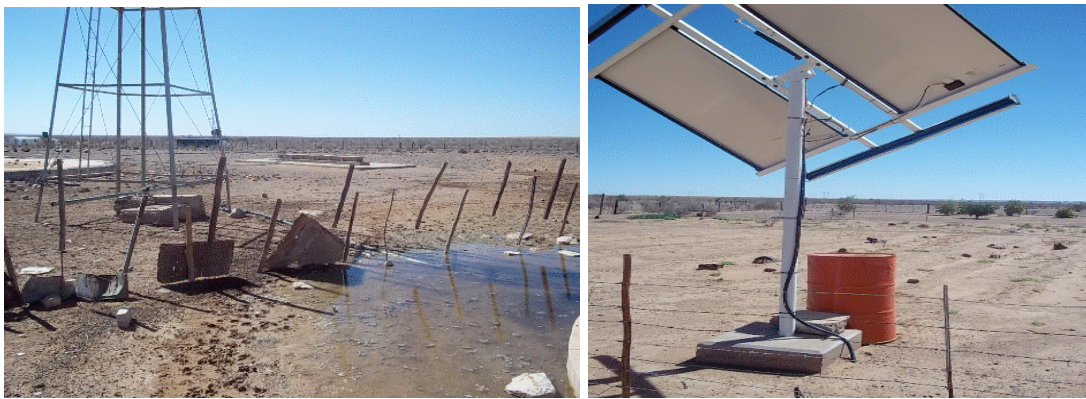
Figure 5 The unrehabilitated water point situated in the kraal area (left) and the solar-pumped borehole (right). The panel is within the fenced-in plantation site.

The borehole at the unrehabilitated water point is located within the kraal which poses a threat to the quality of the groundwater at the farm. The dam has leakages in numerous places and the contaminated standing water around the dam further intensifies the threat to the quality of the groundwater resource in the area.

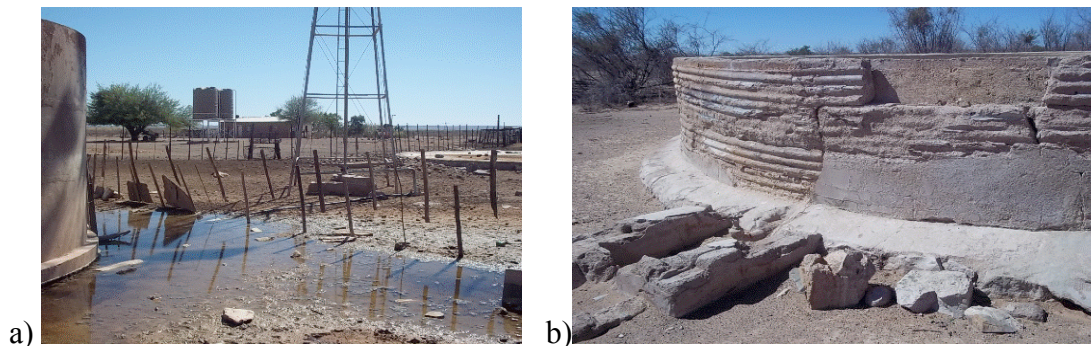
Figure 6 (a) Potential health hazards to community members from contaminated standing water caused by leakages from the 'crumbling' dam and livestock manure. (b) A dilapidated farm dam

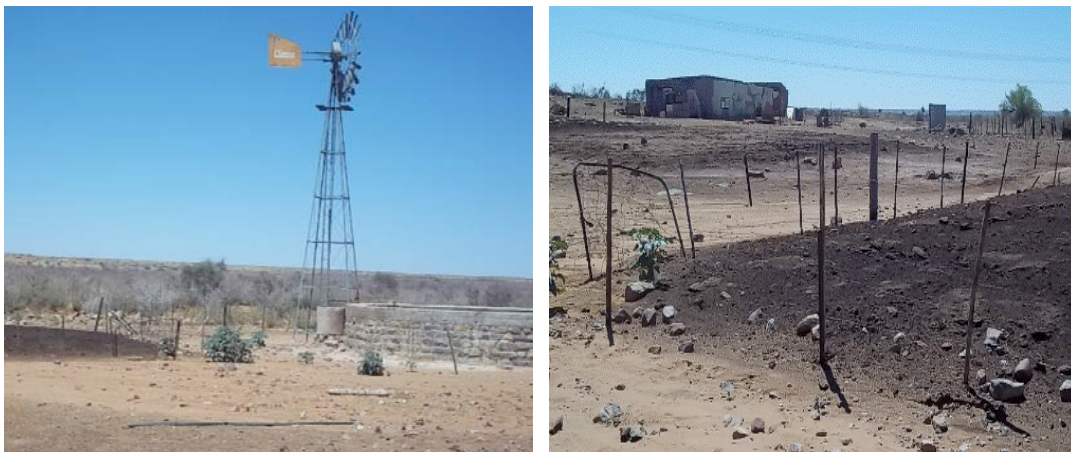
Three households make up this farmland, with a kraal and water trough in close proximity to the borehole. The kraals contain heaps of humus and manure that corresponds to the water quality test results obtained (see results section).

Figure 7 Layout of the farm. The wind-pumped borehole, farm dam, kraal and the households are all in proximity to one another posing threats to individual health and groundwater quality in the area

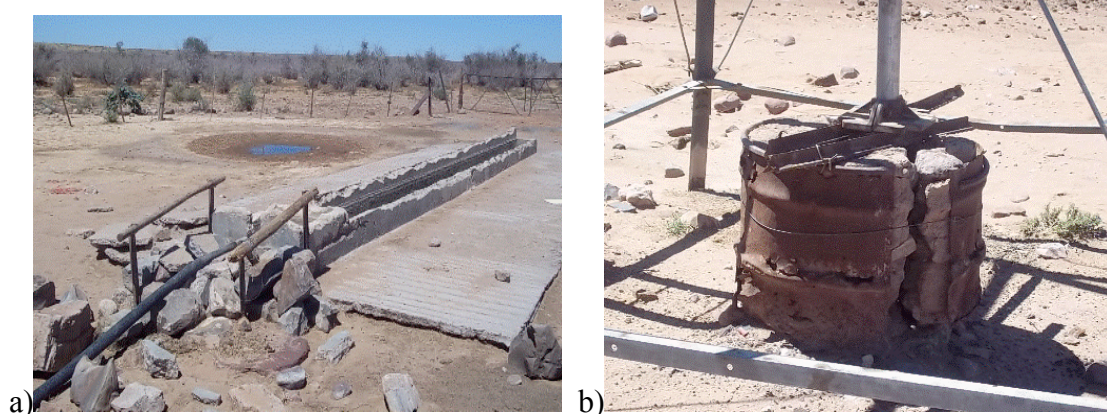
The infrastructures at the farm are in a very bad state, have been for years and no rehabilitation was done.

Figure 8 The bad state of water infrastructure with no intention of rehabilitation. The livestock trough (a) and the windmill foundation (b)

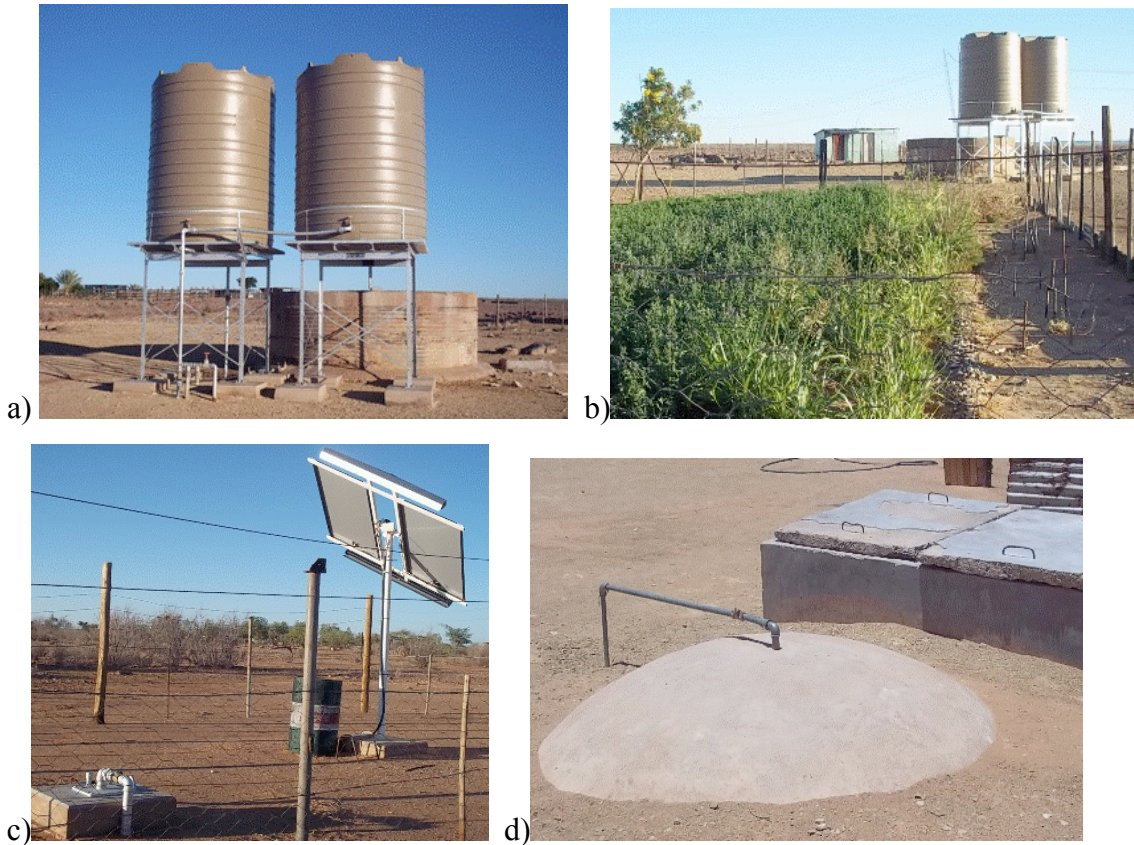
Figure 9 The various infrastructure and activities at the farm. (a) water infrastructure (water tanks, farm dam, taps in the fore) (b) the small garden with visible lucern (c) the solar powered borehole (d) the biogas digester

The water point and the household are solar-powered. The kraal is situated approximately 50-100m away from the water infrastructures which are in good condition as compared to the other visited farms. Of importance, is the biogas digester which it fuelled by livestock waste according to (R1). Biogas refers to gas produced by the breakdown of organic matter or biodegradable substances and the process occurs in the absence of oxygen. The farm owner went on further to say she uses the generated biogas for cooking purposes and it saves on energy consumption. She commended this as a good practice for rural communities as it is cost-effective, and would like to see this initiative being taken up at other farms provided financial support is secured.
